FACILITY STATUS CHANGE FORM

Date Submitted: November 6, 2013 Originator: Chris Strand Phone: 554-2720	Area: 300 Area Facility ID: 3760, 323BA Action Memorandum: Action Memorandum #3	Control #: D4-300-092
---	---	---------------------------------

Attachment 1: Facility Information

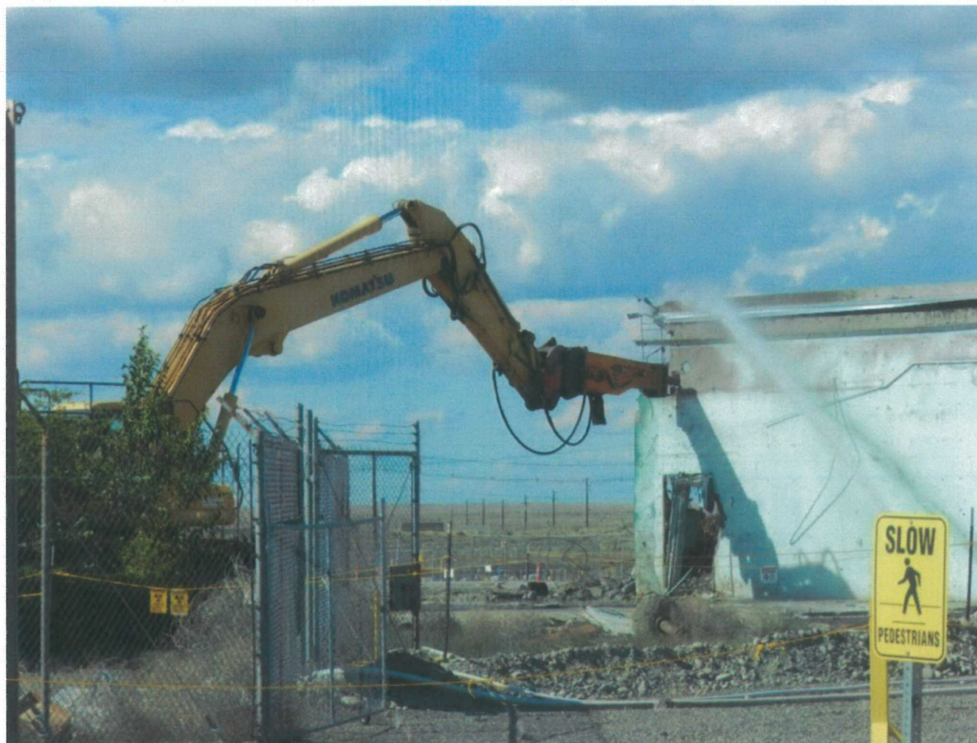
Photograph 4: 3760 Vault during demolition, looking west on September 16, 2013

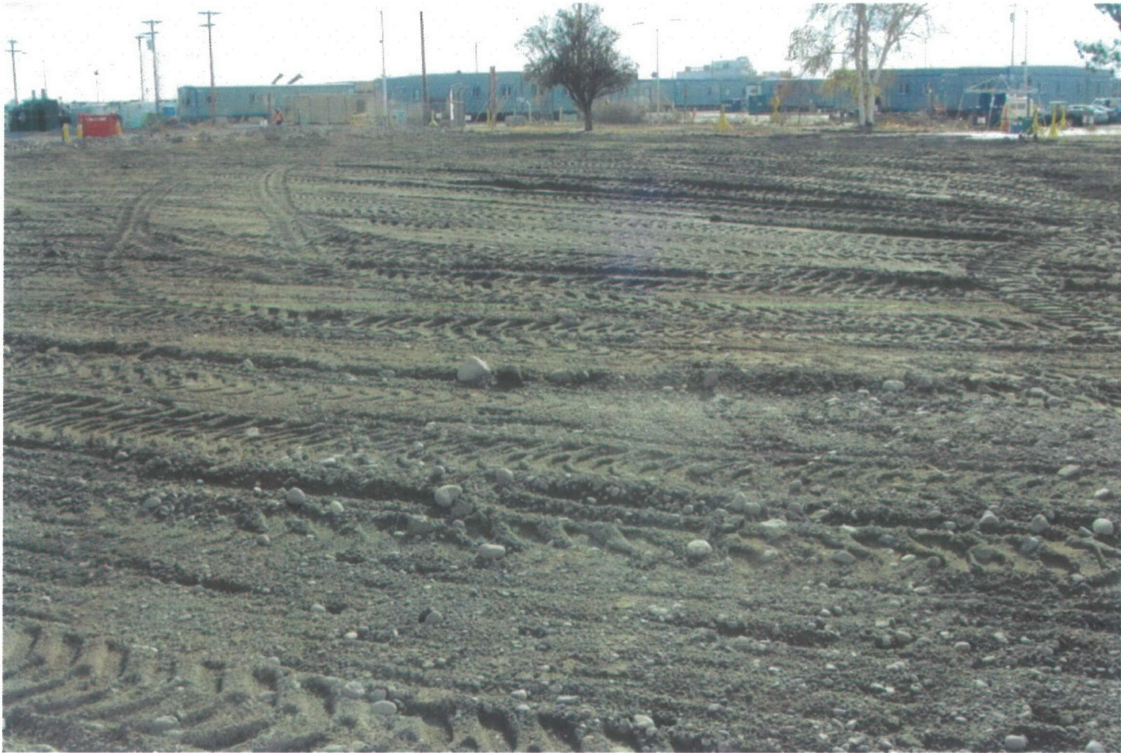
No anomalies were discovered during the below-grade removal of both the 3760 and 323BA foundations. A visual inspection conducted on 10/30/13 identified no soil staining within the excavation. GPERS surveys (Attachment 3) identified no radiological contamination. The common excavation was backfilled with clean fill material.

Photograph 5: 3760/323BA Excavation following below-grade demolition and load-out, looking south east on October 30, 2013

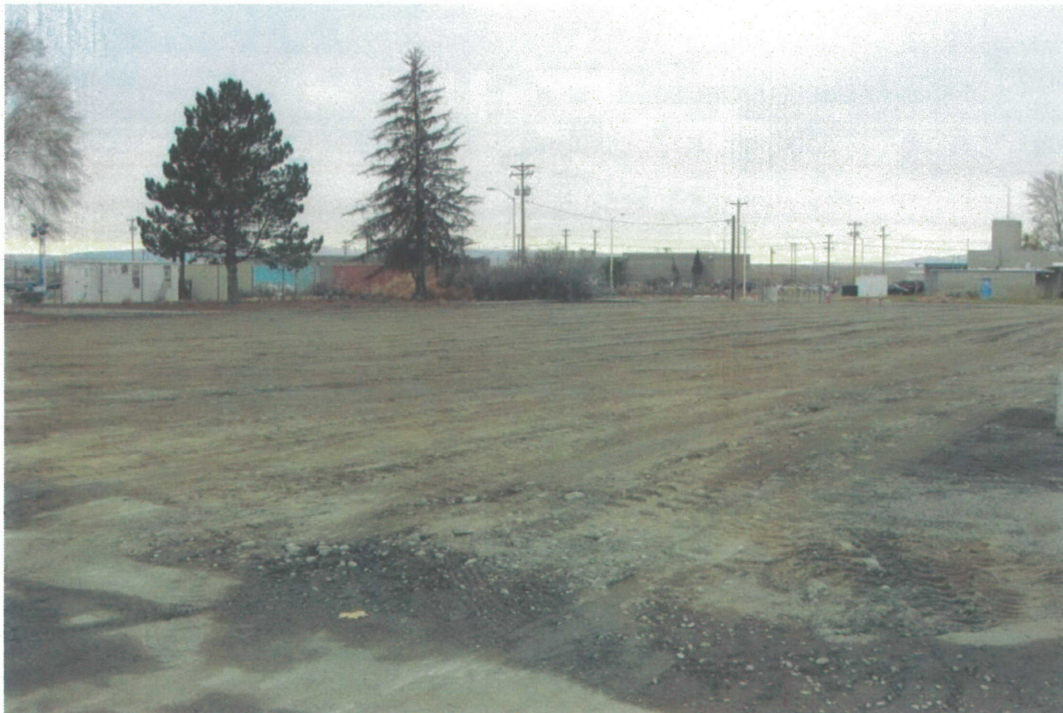
The excavation was backfilled with clean material following GPERS surveys. No radiological or Industrial Hygiene postings remain.

Photograph 6: 3760/323BA Excavation following backfill, looking southwest on November 5, 2013

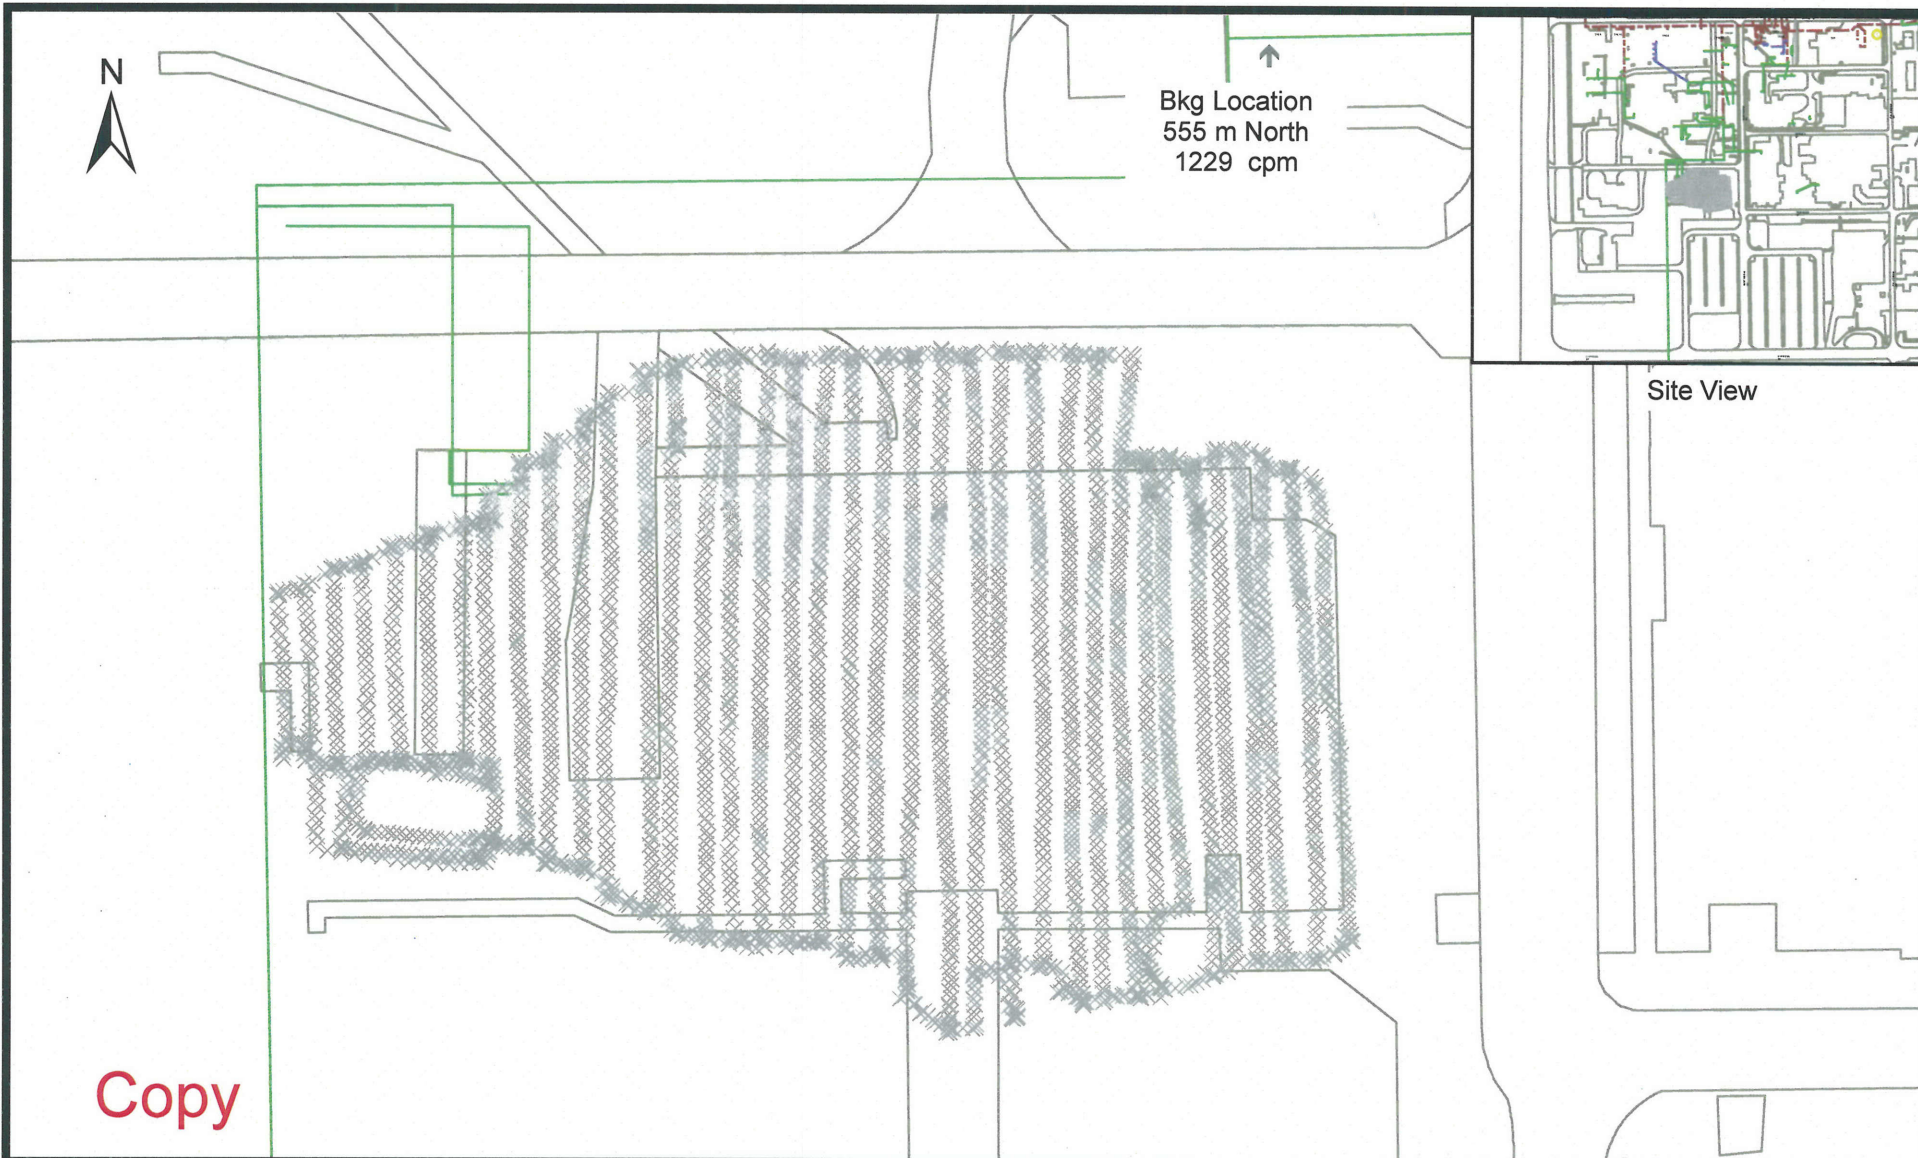
300 D4 3760 and 323-BA GPERS Radiological Survey Beta Track Map

Coverage File: D4_303A
Number of Data Pnts: 362
Type of Survey: beta
Max GCPM: 622
Avg Bkg CPM: 362
Survey Date: 10/30/2013
Area Surveyed: 3,080 m²
Project File: ESRFRM130065B
Pdf File: ESRFRM130065BC
